# TRURO MEETING HOUSE REVERE BELL RESTORATION BY THE VERDIN COMPANY BUILDERS OF FINE BELLS & CLOCKS SINCE 1842 *Friends of the Truro Meeting House – June 22, 2017*

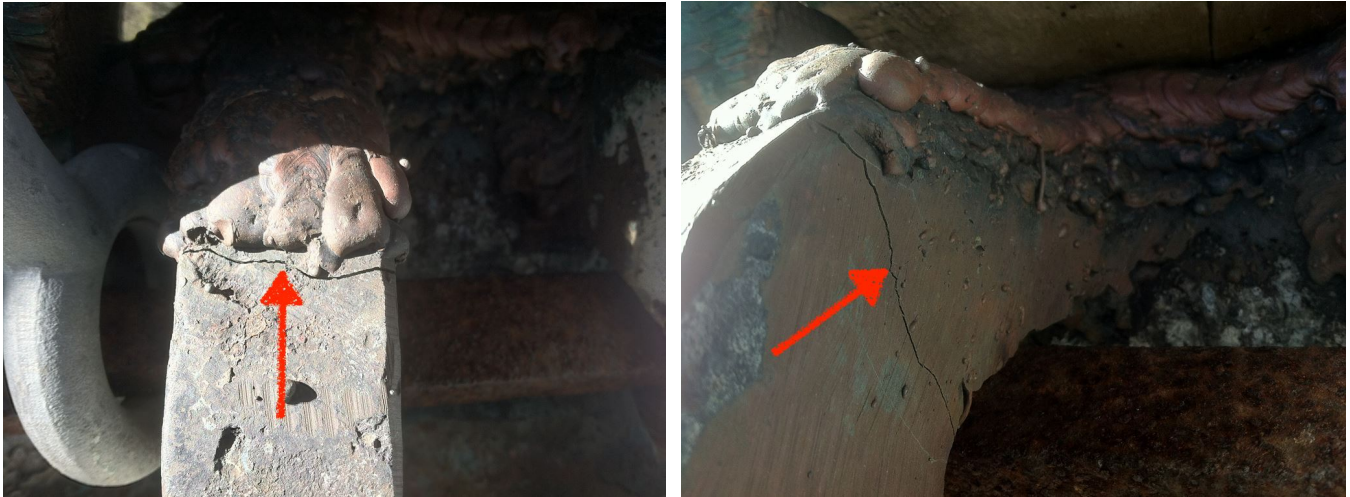
At its foundry, Verdin first removed all of the bell hardware and then bead blasted the bell to remove the paint, corrosion and other contaminants to return the surface down to bare bronze. This was necessary for Verdin to conduct its testing. A visual inspection of the top of the bell clearly revealed the cracks resulting from the previous faulty repair. Further testing was required to evaluate the full extent of those cracks.

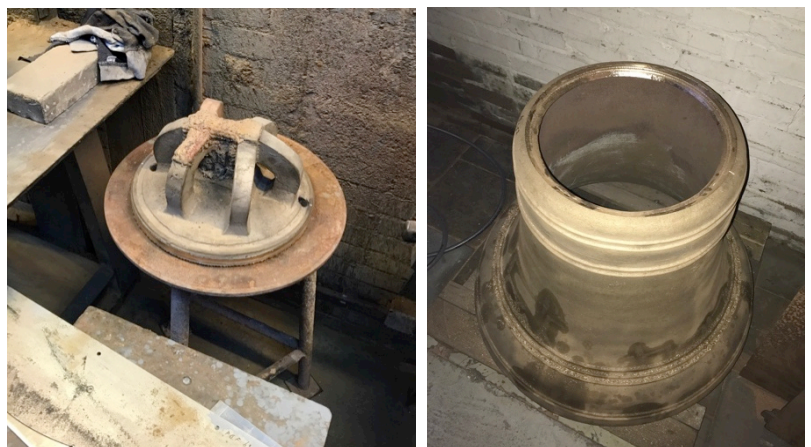
The next step in the repair process was to remove enough of the old crown of the bell to include all portions that contained cracks in the casting. Had even the smallest cracks remained, they would have continued to grow when the bell was rung. To remove the crown, the bell was clamped to a vertical lathe and rotated against a tool, which cut all the way through the casting. Once the crown was off, the same tool was used to chamfer the edges of the cut, first on the outside, and then on the inside once

the bell had been flipped upside down. Chamfering the edges would later enable the new crown to be welded to the bell.

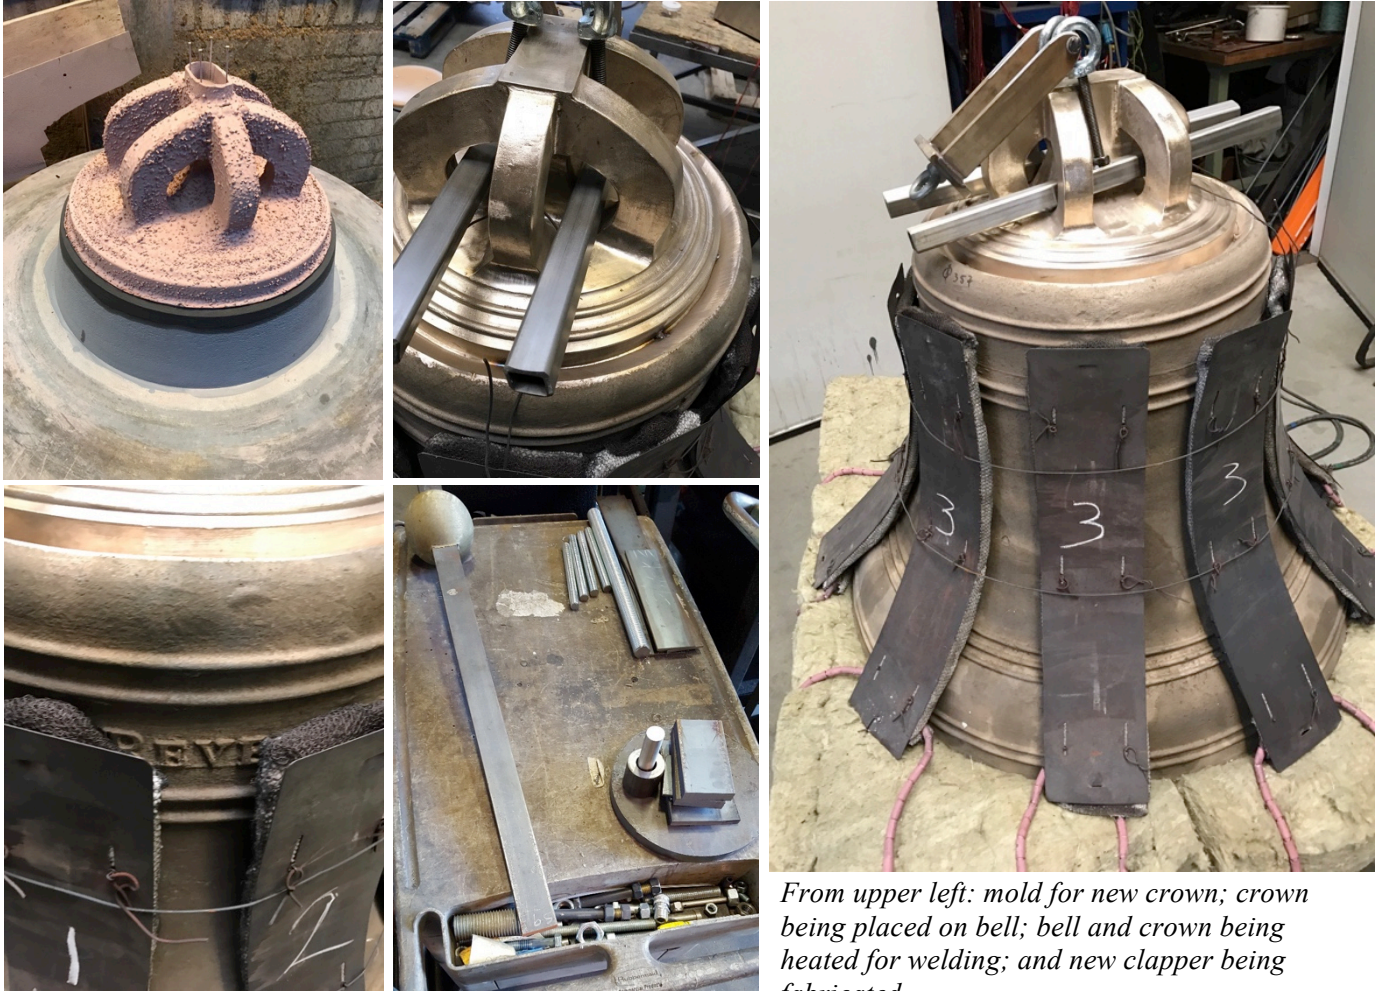
*From upper left: mold for new crown; crown being placed on bell; bell and crown being heated for welding; and new clapper being fabricated.*

The old crown was ground back into its original shape to become a pattern for the new crown. From that, a wax crown was created so that a “lost-wax” ceramic mold could be formed for casting the new crown. An alloy, which is very close to the original bell alloy, was poured into the mold to reproduce a crown identical to the original.

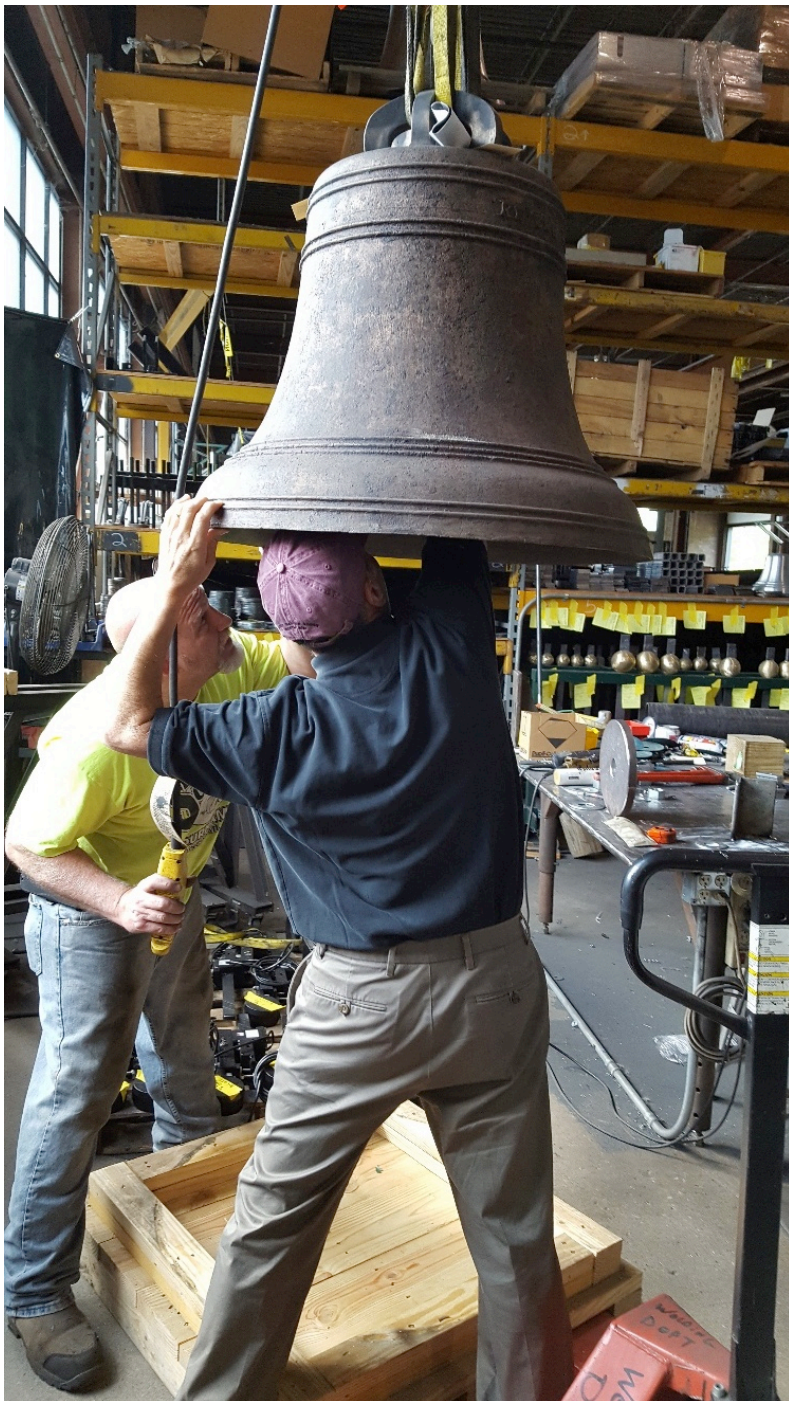
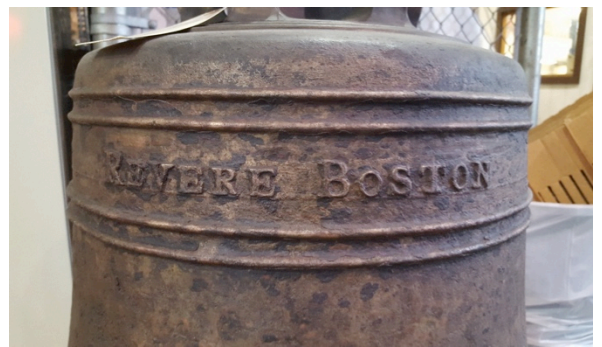
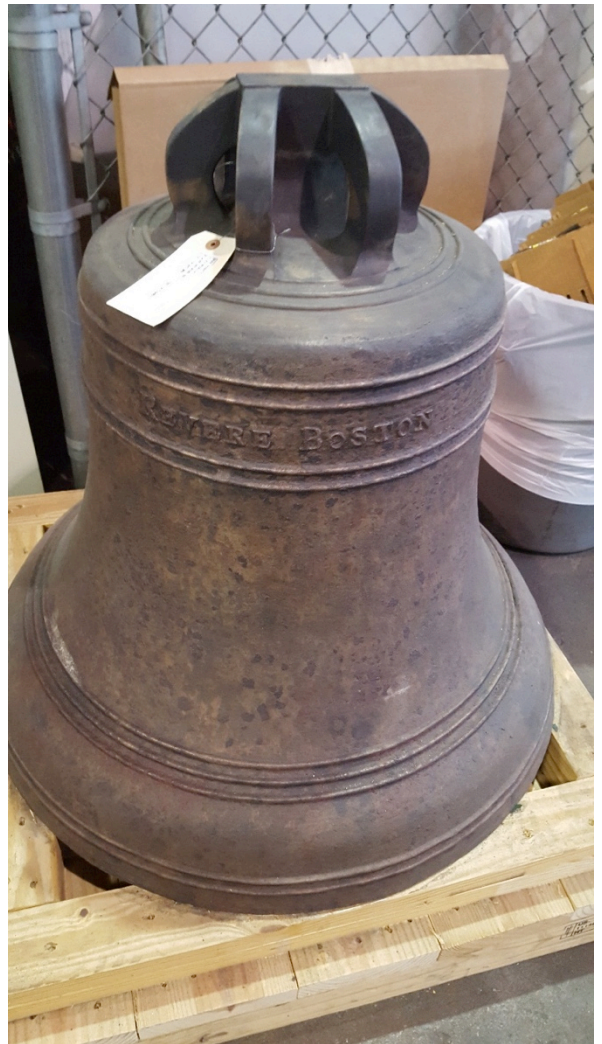
*Restoration of the Truro Meeting House Revere Bell being completed at the Verdin Factory, Cincinnati, Ohio.*

Once the new crown was cast and ready, heating elements and blankets were used to slowly heat the entire bell up to a specific temperature. Because of the thickness of the casting, it was necessary to heat the entire bell so that the weldment would cool very slowly over time. If the weldment cools too quickly, it has the possibility to become brittle. When the welding was complete, the bell was cooled down over a period of several days until it reached ambient temperature. The last step of the repair process was grinding and smoothing the weldment to make it look like it was never there. At this point, a patina was applied to the bell so it looks like the originally cast bell, but with the new integral crown. Next, the clapper shank was completed and a bronze ball cast. After it was removed from the mold it was transferred to the machining department for completion. Shown on the next page are photos of the repaired bell being adjusted in the Verdin factory and readied for shipment.
