# Are the bells in your tower safe?

# 8 things that should be checked every year to keep your bells safe.

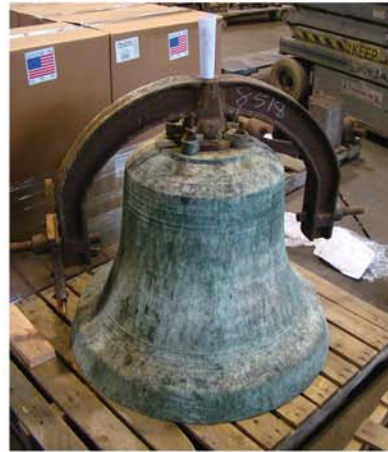
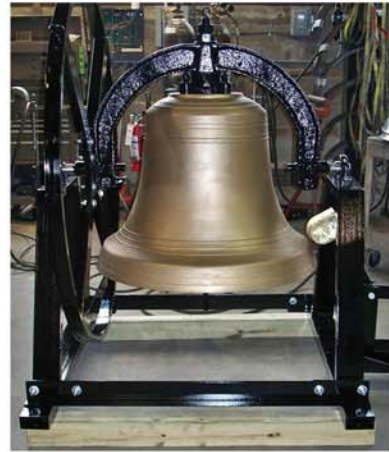
Before

After

Verdin manufactures new bell ringing equipment and hardware to restore bells to their original beauty and resonance and to keep them safe. Since 1842, Verdin has been servicing bells at churches, town halls, and universities around the world. Bell repair and restoration are important hallmarks of our business. Verdin provides customers with the industry's most experienced bell repair and restoration team — all backed by the most respected, financially sound bell company in the country.

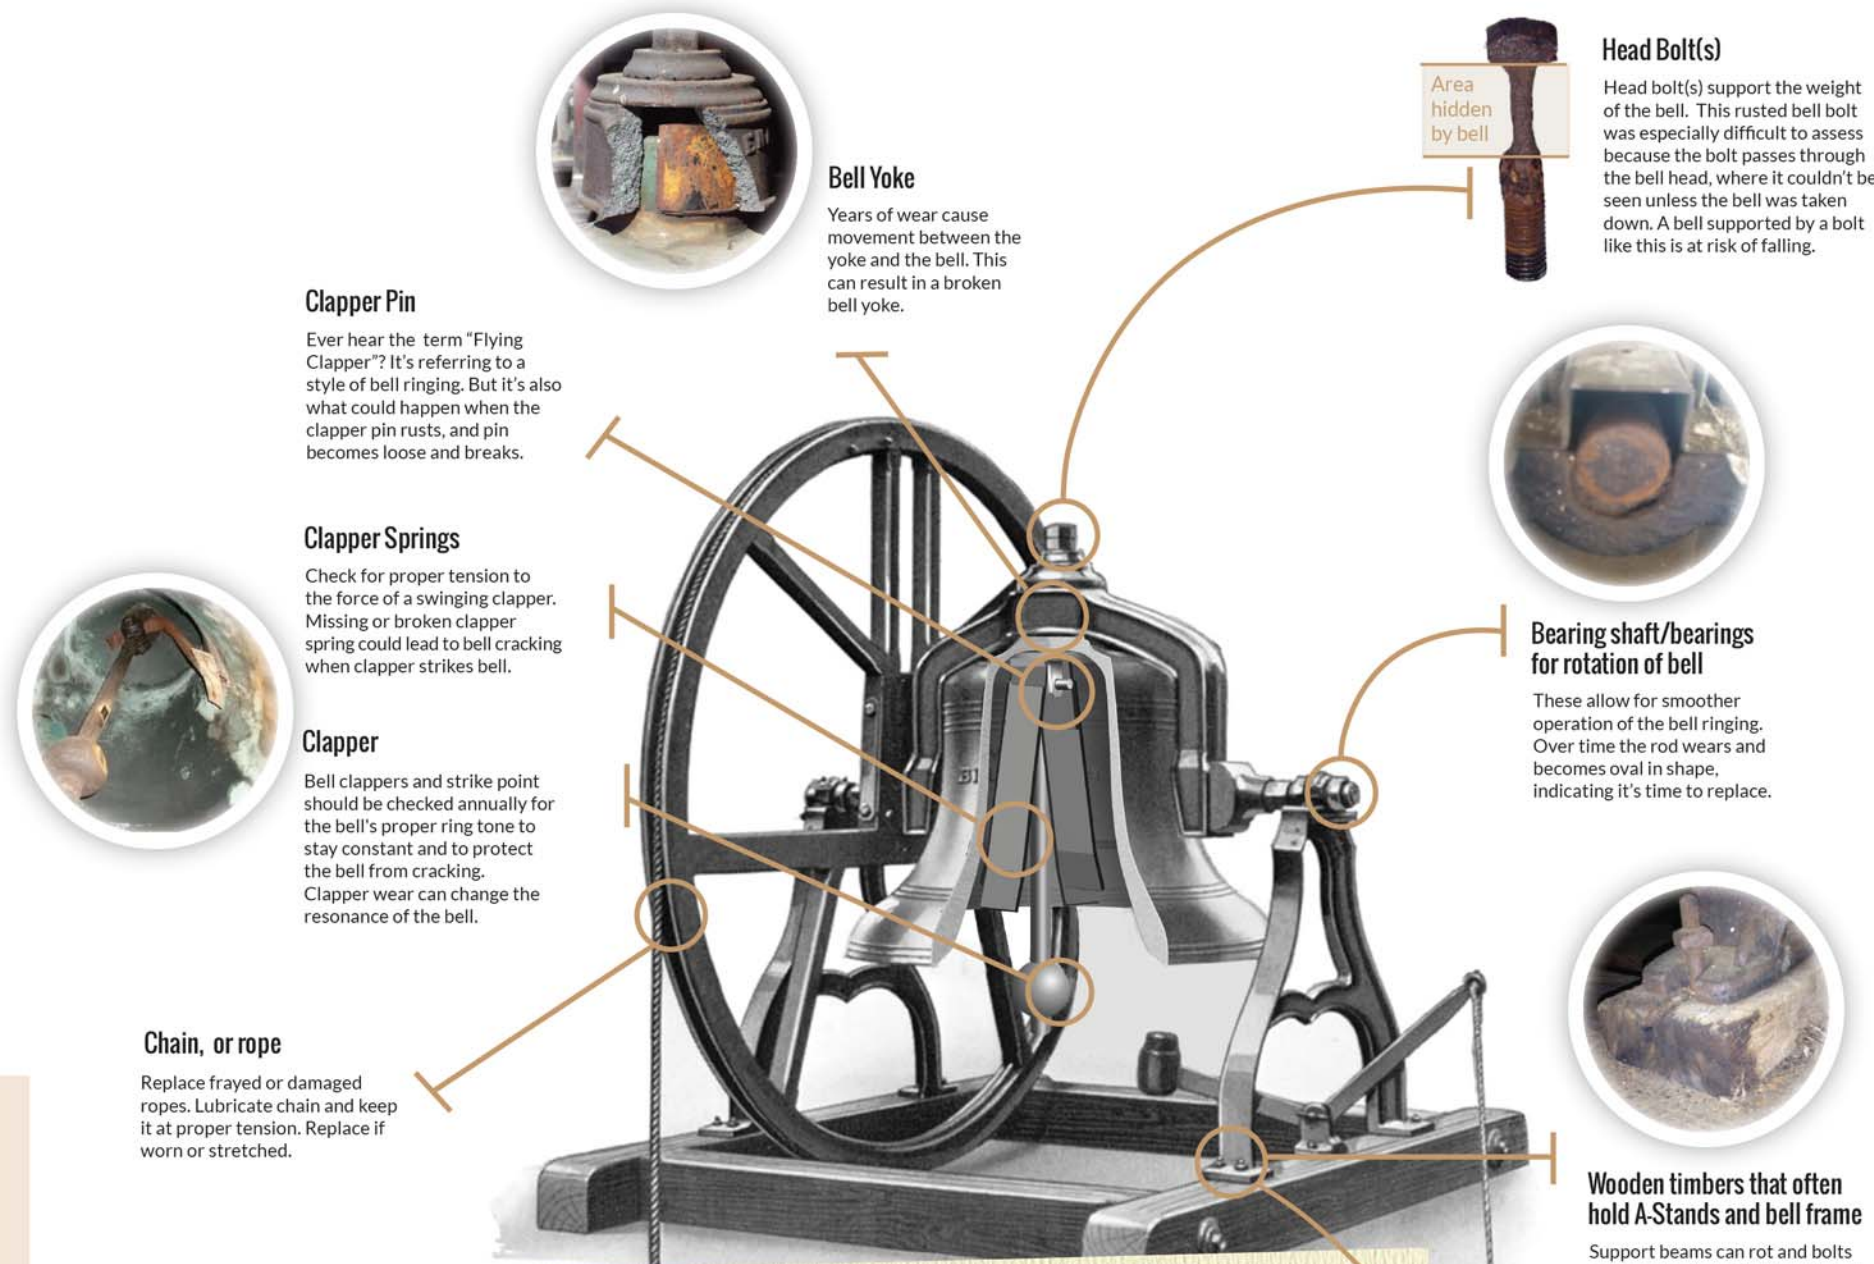
### Clapper Pin

Ever hear the term "Flying Clapper"? It's referring to a style of bell ringing. But it's also what could happen when the clapper pin rusts, and pin becomes loose and breaks.

### Clapper Springs

Check for proper tension to the force of a swinging clapper. Missing or broken clapper spring could lead to bell cracking when clapper strikes bell.

### Clapper

Bell clappers and strike point should be checked annually for the bell's proper ring tone to stay constant and to protect the bell from cracking. Clapper wear can change the resonance of the bell.

### Chain, or rope

Replace frayed or damaged ropes. Lubricate chain and keep it at proper tension. Replace if worn or stretched.

### Bell Yoke

Years of wear cause movement between the yoke and the bell. This can result in a broken bell yoke.

### Head Bolt(s)

Head bolt(s) support the weight of the bell. This rusted bell bolt was especially difficult to assess because the bolt passes through the bell head, where it couldn't be seen unless the bell was taken down. A bell supported by a bolt like this is at risk of falling.

### Bearing shaft/bearings for rotation of bell

These allow for smoother operation of the bell ringing. Over time the rod wears and becomes oval in shape, indicating it's time to replace.

### Wooden timbers that often hold A-Stands and bell frame

Support beams can rot and bolts can become loose, leaving the bell at risk of falling. Some towers and supporting structures may no longer be stable enough to handle the swing of a bell. These bells can be immobilized and a stationary bell ringer installed.
