# TRURO MEETING HOUSE REVERE BELL RESTORATION BY THE VERDIN COMPANY BUILDERS OF FINE BELLS & CLOCKS SINCE 1842 *Friends of the Truro Meeting House – June 22, 2017*

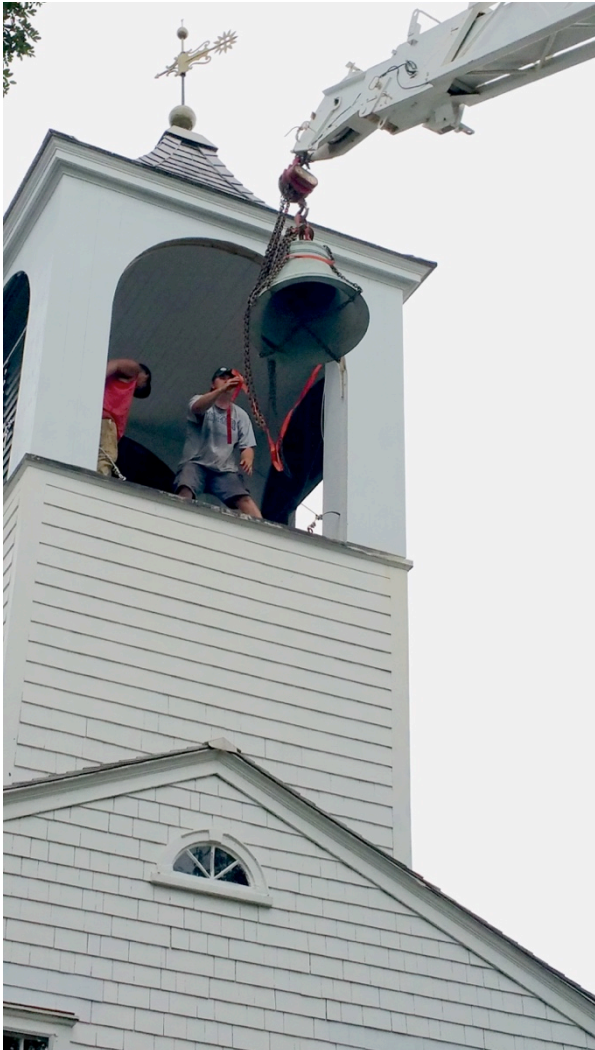
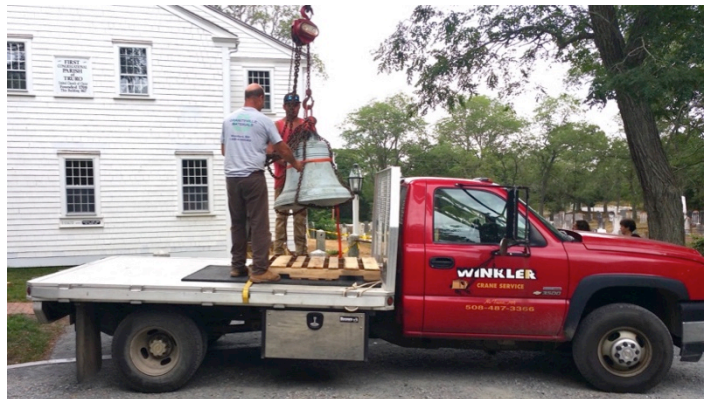
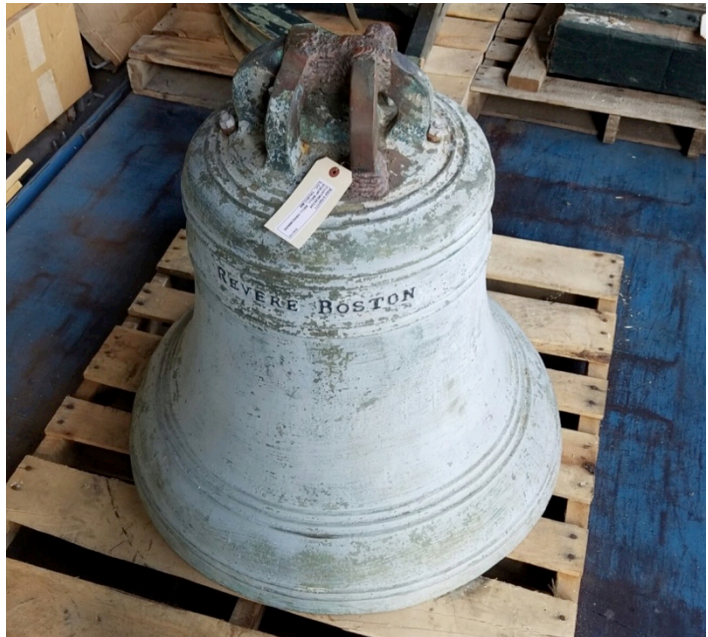
*Photos of bell removal and arrival at Verdin Co.*

The first step was to remove the bell from the tower and ship it to the Verdin factory in Cincinnati so that it could be thoroughly examined and evaluated.

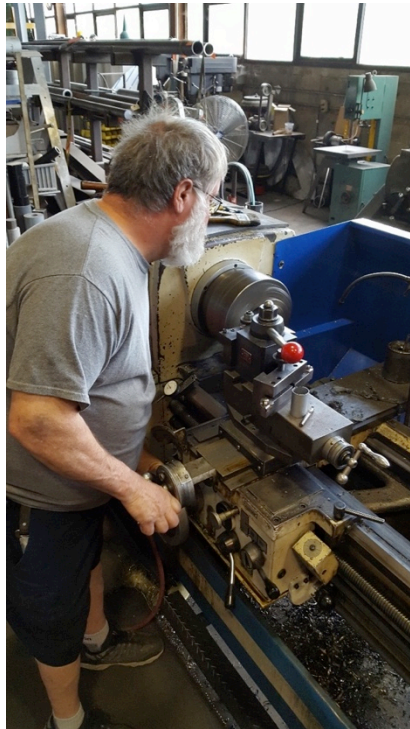
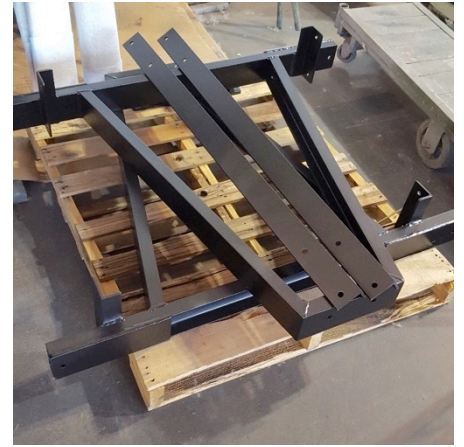
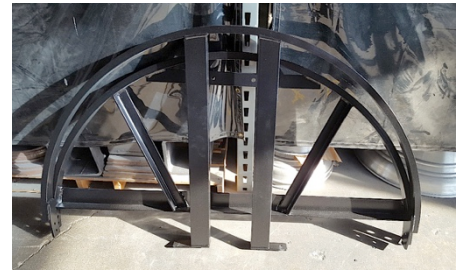
*The photos show machining during the fabrication process; completed A-stands; and the completed wheel.*

The material for the A-stands was cut and machined, holes drilled, and angle cuts made for the fit-up, welding and painting of those parts. Similarly the material for the wheel was fabricated for the fit-up, welding, and painting.

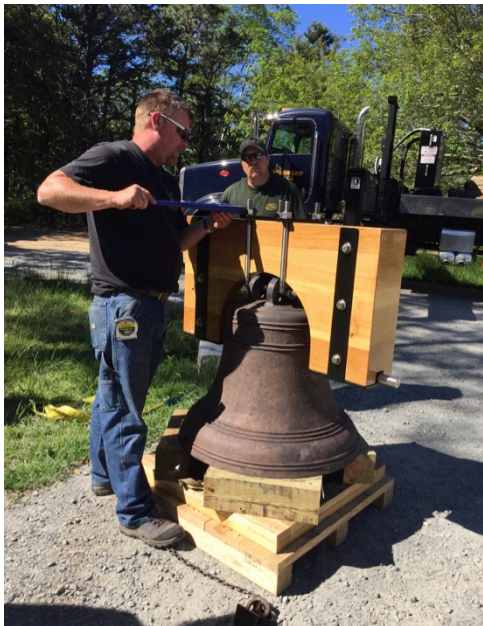
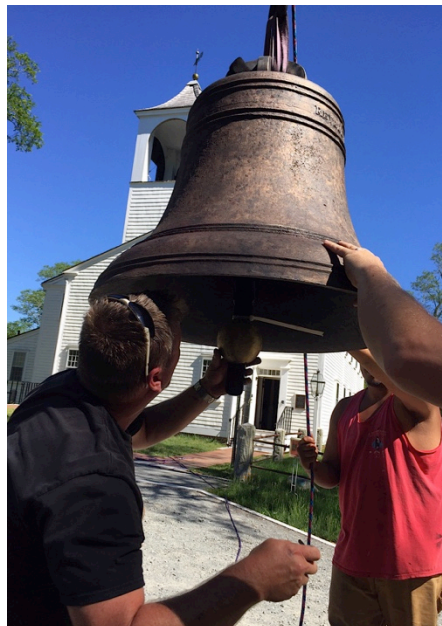
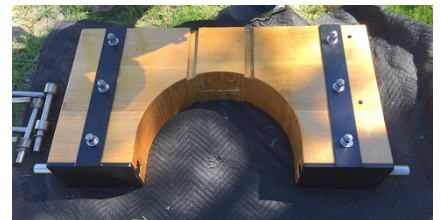
*The photo at left shows the bell arriving with yoke and clapper attached. Both needed to be taken off the bell for it to fit into the tower. Photos at right show the new yoke and clapper.*

Delivered from Cincinnati on a Verdin truck, the bell arrived in Truro with the new wooden yoke attached and the new fabricated steel headpiece and springs installed. The A-stands were in four pieces: two A-stands ends and two spreaders. The wheel was in two halves. The clapper, pillow block bearings, and rope were boxed.
